INDOOR AIR QUALITY ASSESSMENT

**Norton Municipal Center
70 East Main Street
Norton, Massachusetts**

Prepared by:
Massachusetts Department of Public Health
Center for Environmental Health
Emergency Response/Indoor Air Quality Program
June 2005

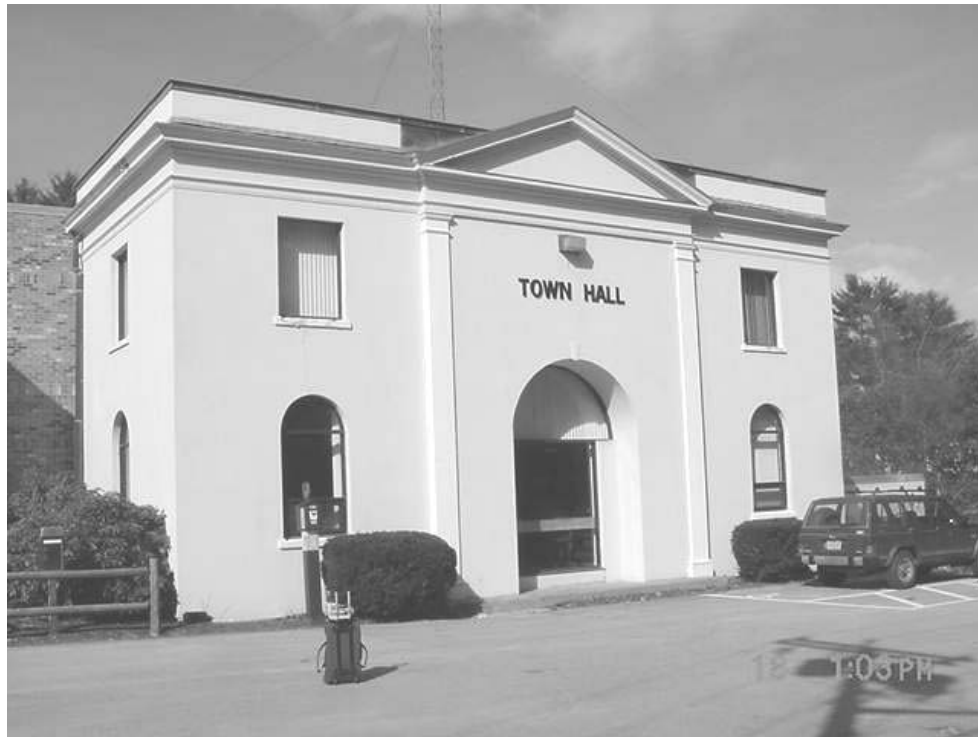
Picture 1

Norton Town Hall

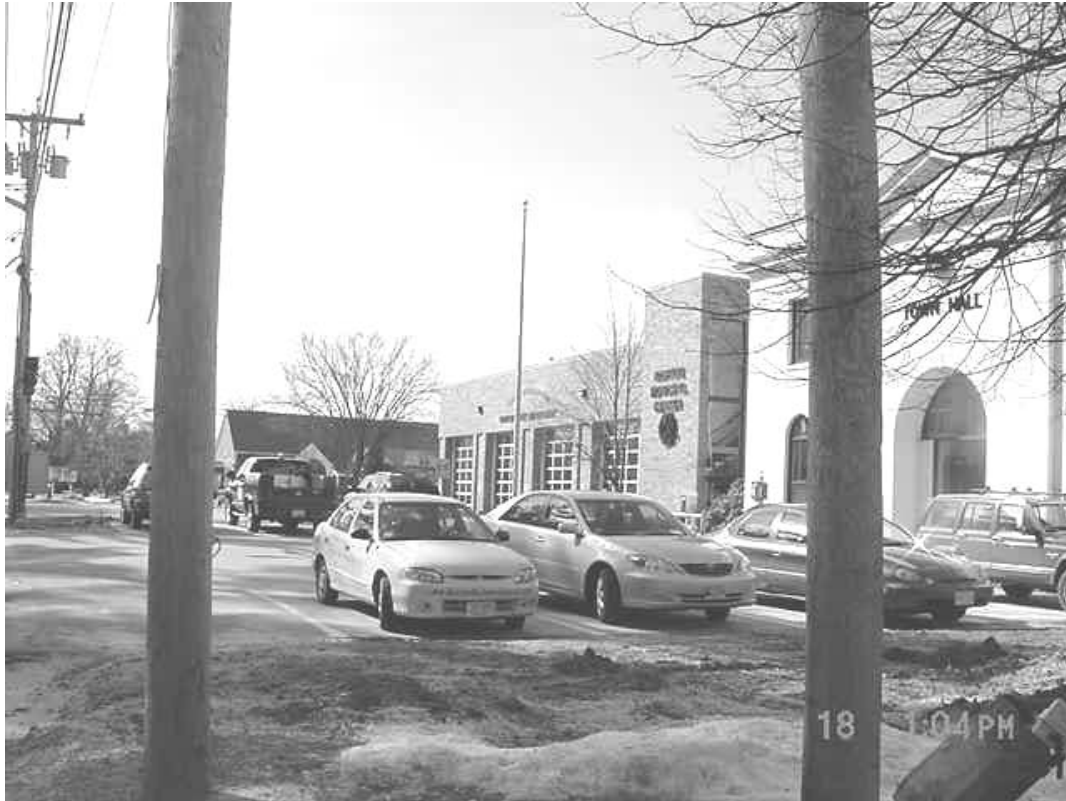
Picture 2

Norton Municipal Center, Norton Fire Department on Left, Town Hall on Right

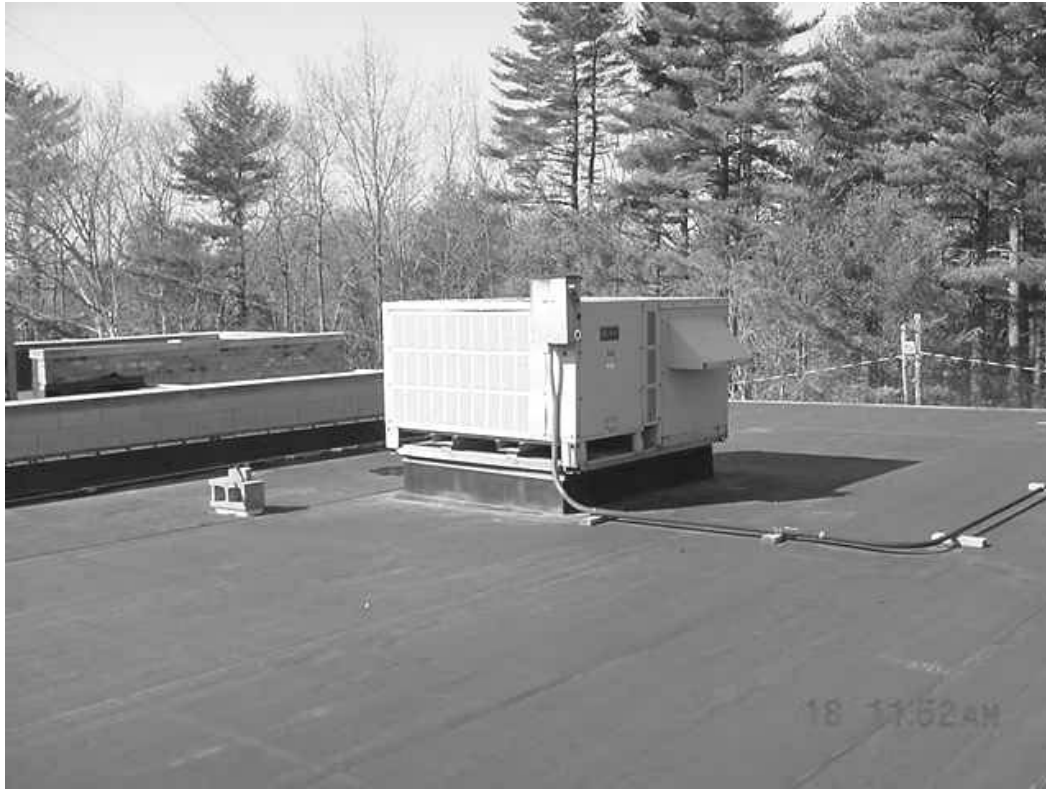
Picture 3

Small Rooftop AHU

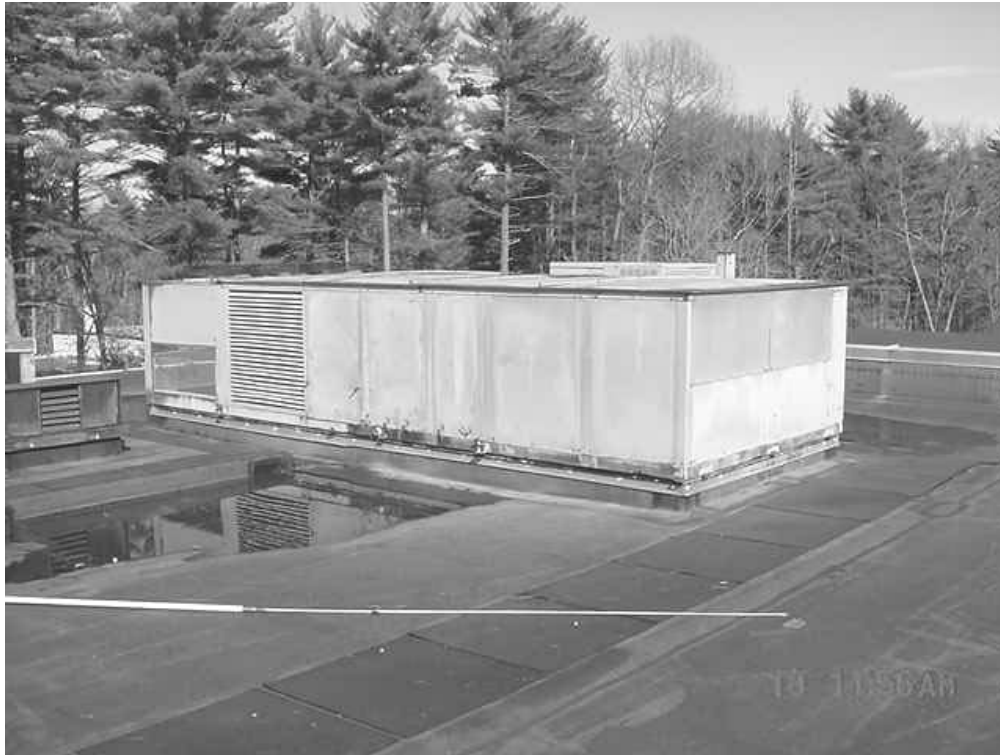
Picture 4

As previously noted in the ventilation section of this report, the casings of AHUs appeared damaged. A depression on the top of the large AHU in Pictures 4, 8 and 9, which appears to have been patched several times, is an indent into where rainwater accumulates. Accumulated debris (e.g., dust, dirt) was found inside the AHU cabinet (Picture 14). These materials can provide a medium for mold growth if it becomes wet. If these materials become colonized with microbial growth, spores can be distributed to occupied areas via the ventilation system.

Large Rooftop AHU

2. Contact an HVAC engineering firm to clean out and make necessary repairs to the casing of the large rooftop AHU.
3. To maximize air exchange, operate ventilation systems throughout the building continuously during periods of occupancy independent of thermostat control.

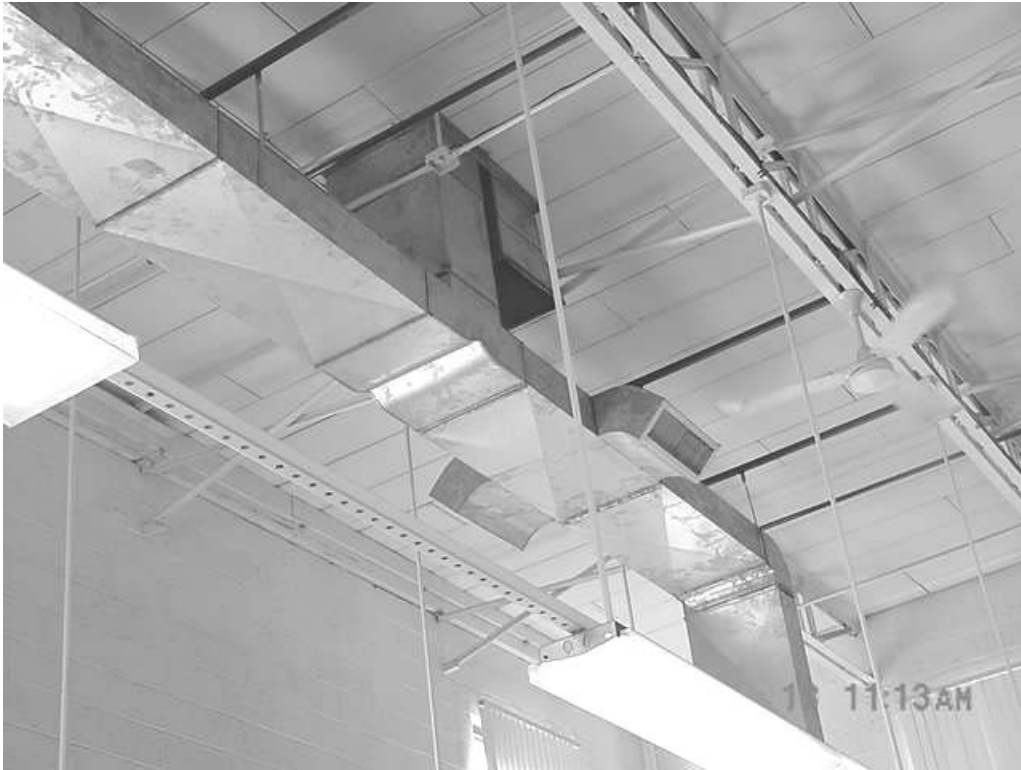
Picture 5

Ducted Supply and Return Vents

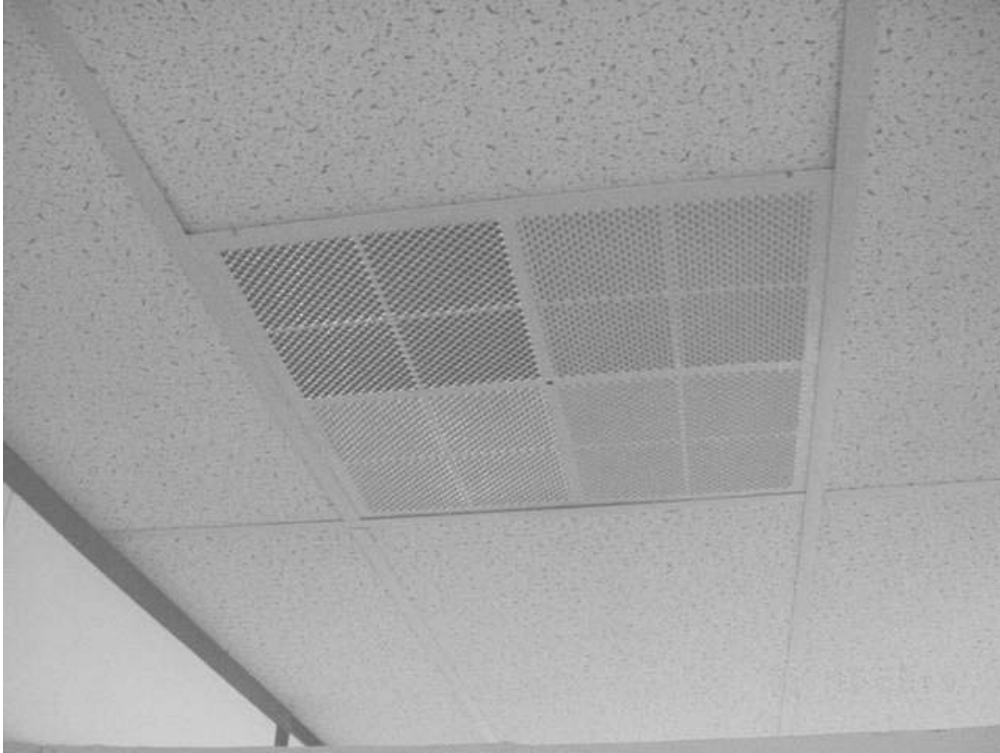
Picture 6

Grated Supply Vent

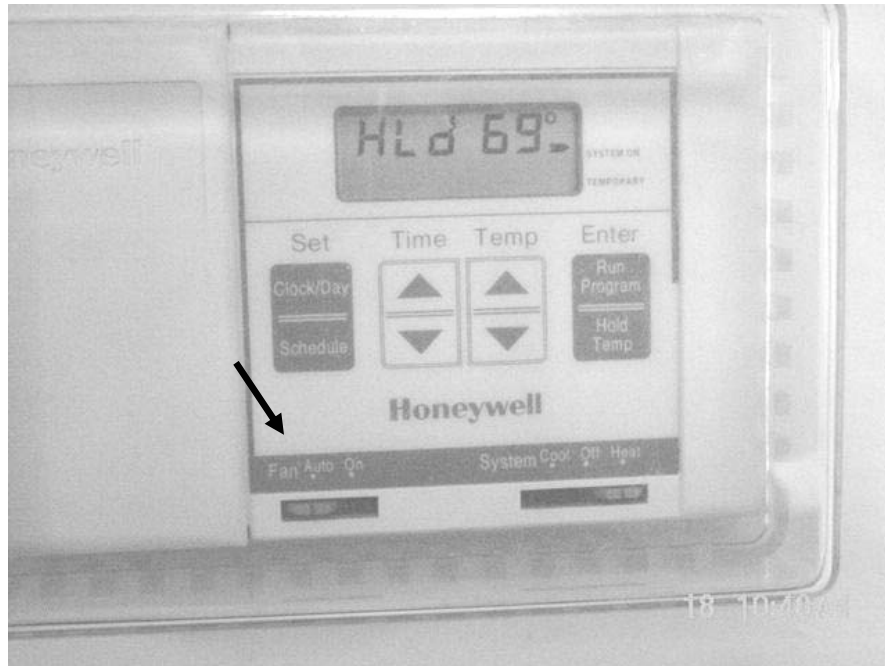
Picture 7

Thermostat for HVAC System, Note Fan Switch to “Auto” Setting

4. Operate thermostats in the fan “on” setting during occupancy to provide continuous air circulation.
5. Remove blockages (i.e., plastic sheeting) from supply vents.

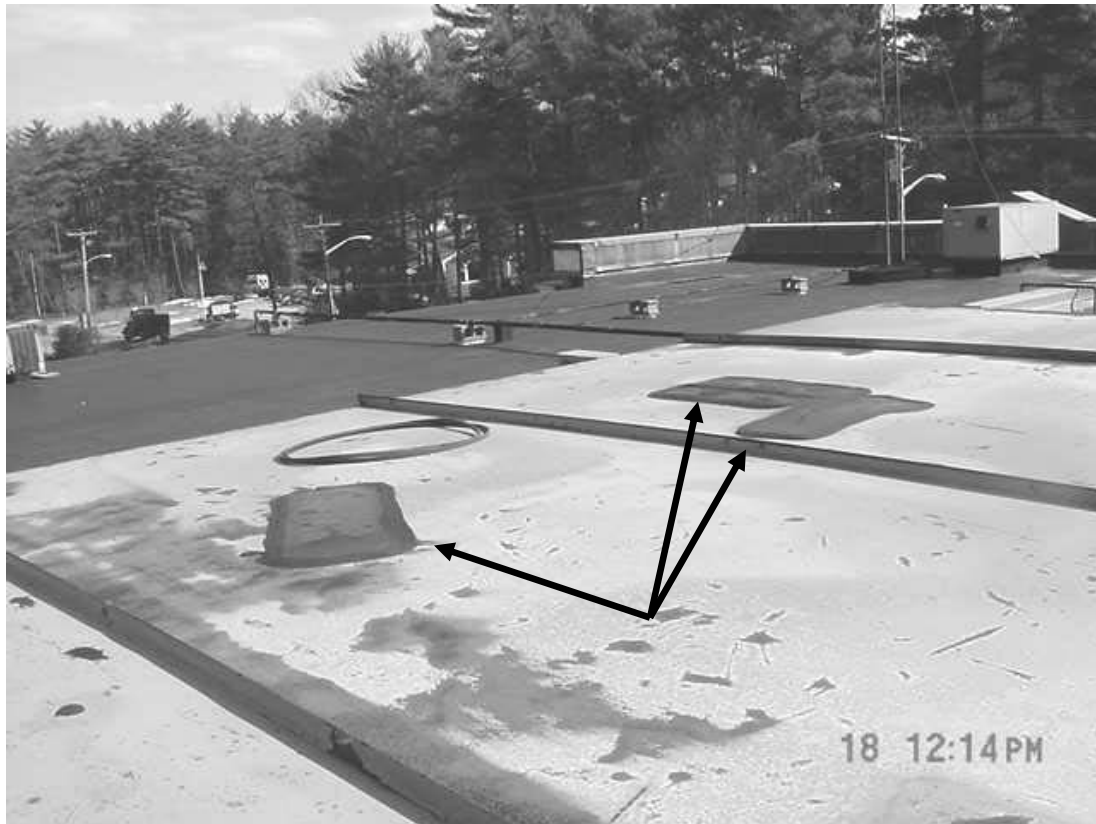
Picture 8

The condition of the larger (and older) of the two rooftop AHUs appeared to be poor. The metal casing of the AHU was severely corroded, weathered and physically damaged (Pictures 8 through 10). The condition of the AHU is discussed in further detail in the Microbial/Moisture Concerns section of this assessment.

**Top View of Large AHU Note Corrosion Indicated by Dark Areas,
Also Note Patches Indicated by Arrows**

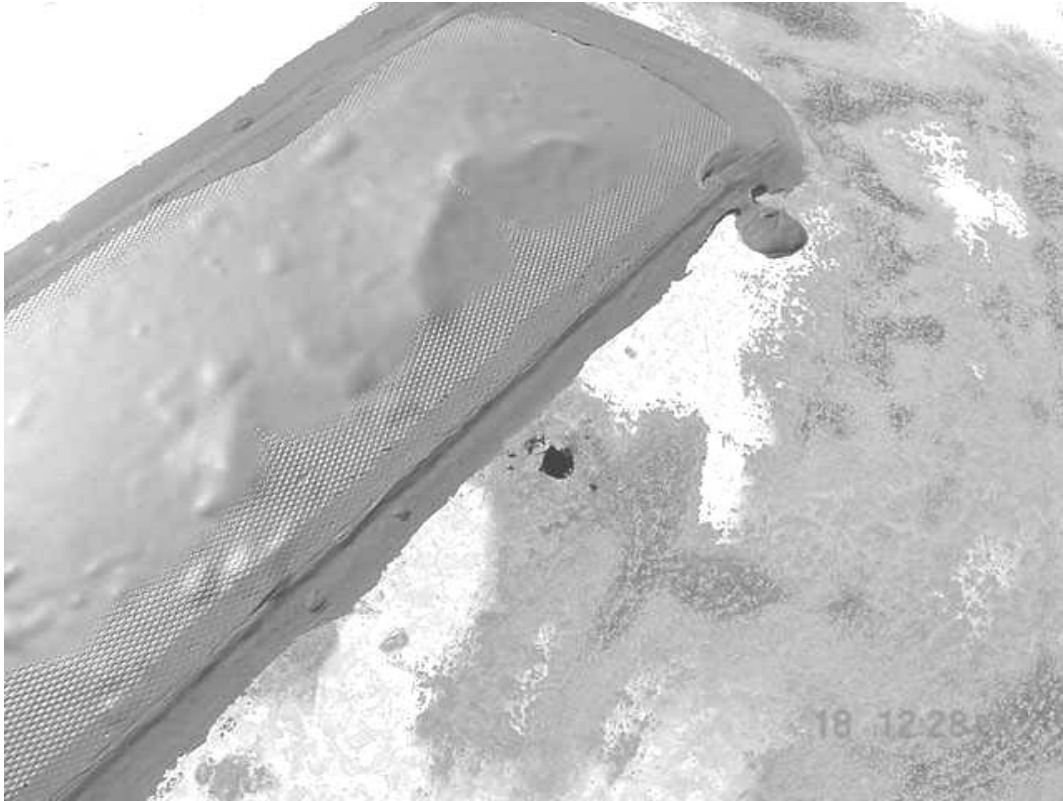
Picture 9

Close-Up of Corrosion and Patch on Top of Large AHU Casing

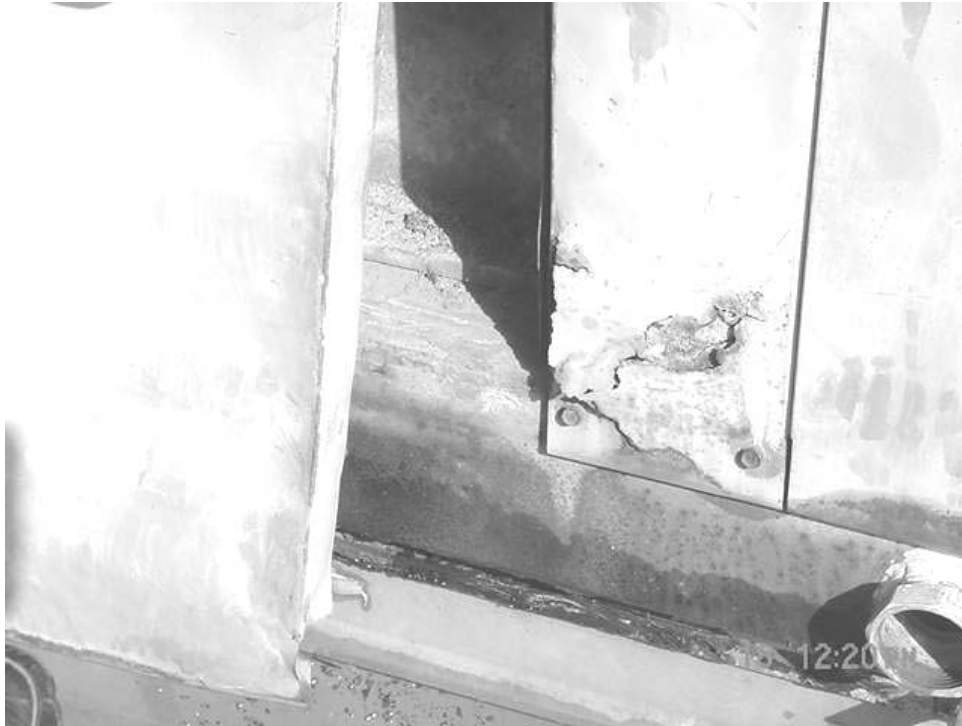
Picture 10

Damaged Access Panel and Corrosion on Side of Large AHU Casing

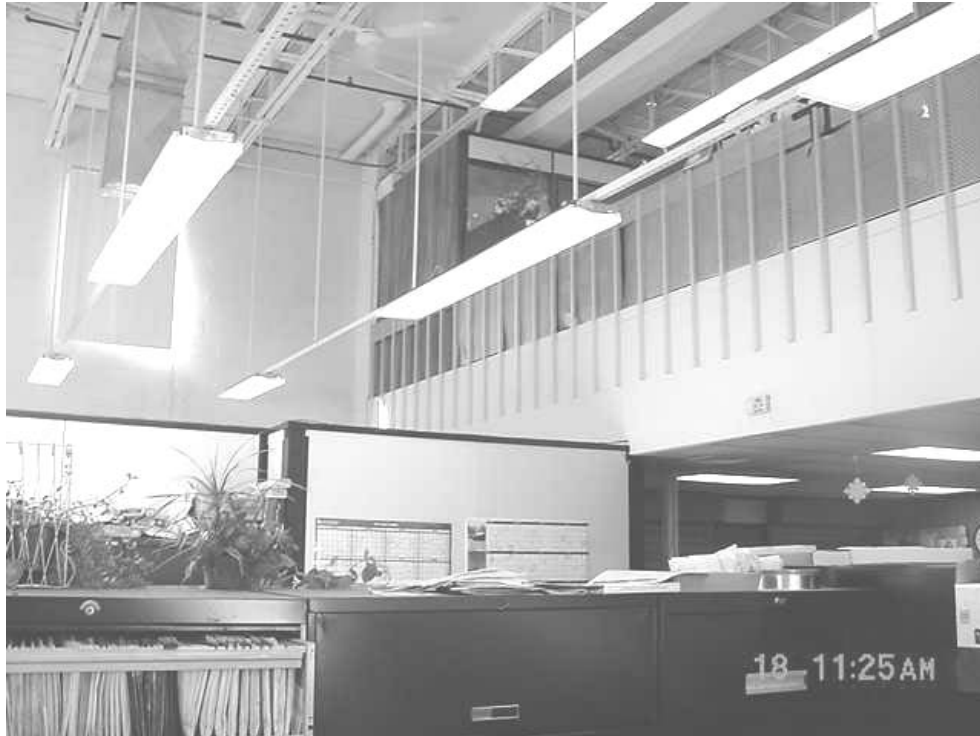
Picture 11

**Large Open Former Gymnasium Area that Houses the Treasure's Office,
Note Semi-Enclosed Second Level**

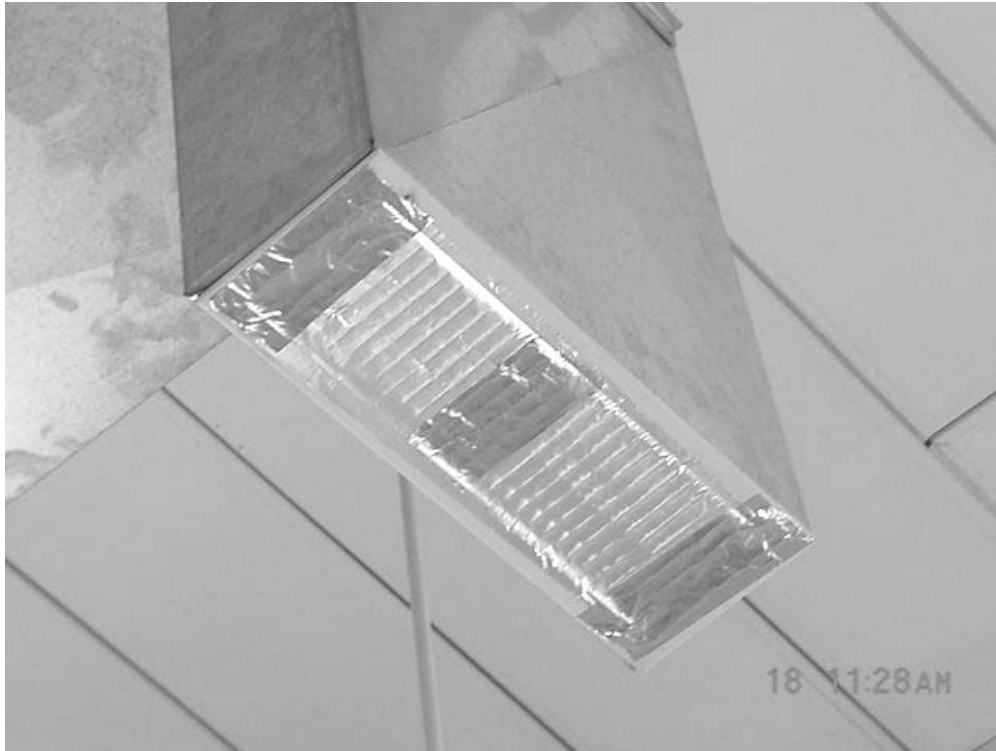
Picture 12

Supply Vent Sealed with Plastic and Duct Tape

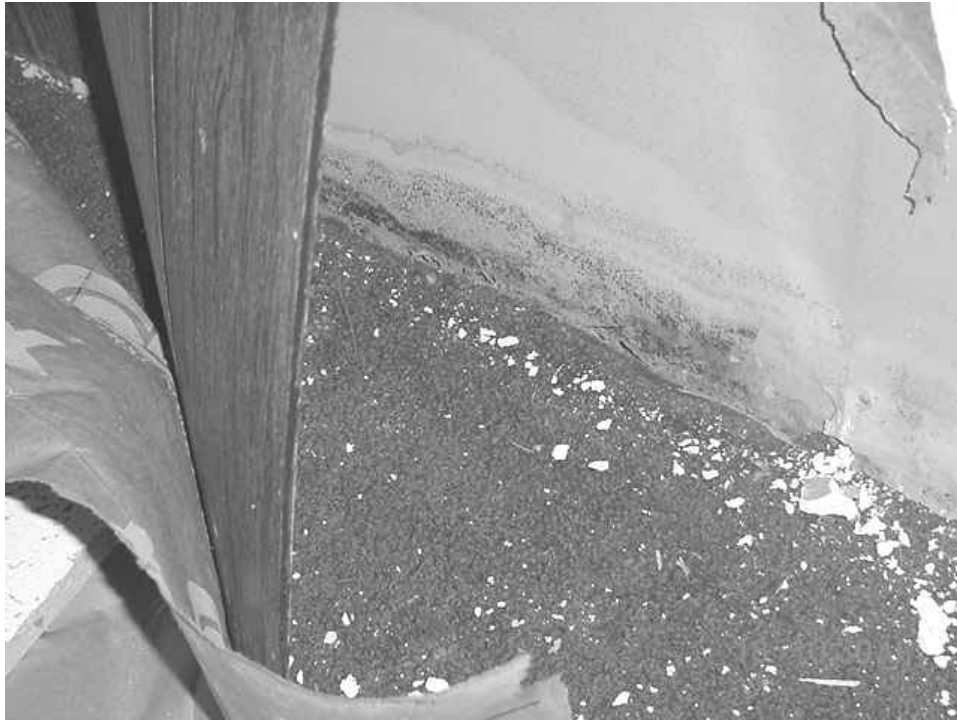
Picture 13

As discussed, the basement is currently unoccupied; however, town officials may renovate the space for future use. Wall materials in the basement appeared to be water damaged. Mold growth was observed on gypsum wallboard (GW) in the room adjacent to the former police photo lab (Picture 13). Carpeting in the basement also had a musty odor (Picture 13). Mold and related particulates can be irritating to sensitive individuals. In order for building materials to support mold growth, a source of moisture is necessary. Identification and elimination of water moistening building materials is necessary to control mold growth. No obvious source of plumbing leaks or water infiltration were identified. The most likely source of moisture in this area would be historically elevated relative humidity and condensation during summer months, due to lack of ventilation and temperature control. Porous materials (e.g., carpeting and GW) that are wetted repeatedly can provide a medium for mold growth. Mold, odors and related particulates can be irritating to sensitive individuals.

Mold Growth on GW and Musty Carpeting in Unoccupied Basement (Former Police Department Area)

1. Remove and replace any mold contaminated/water damaged GW, wooden baseboard/trim and carpeting in the basement. This measure will remove actively growing mold colonies that may be present. Remove mold contaminated materials in a manner consistent with recommendations found in “Mold Remediation in Schools and Commercial Buildings” published by the US Environmental Protection Agency (US EPA, 2001). Copies of this document can be downloaded from the US EPA website at: http://www.epa.gov/iaq/molds/mold_remediation.html.

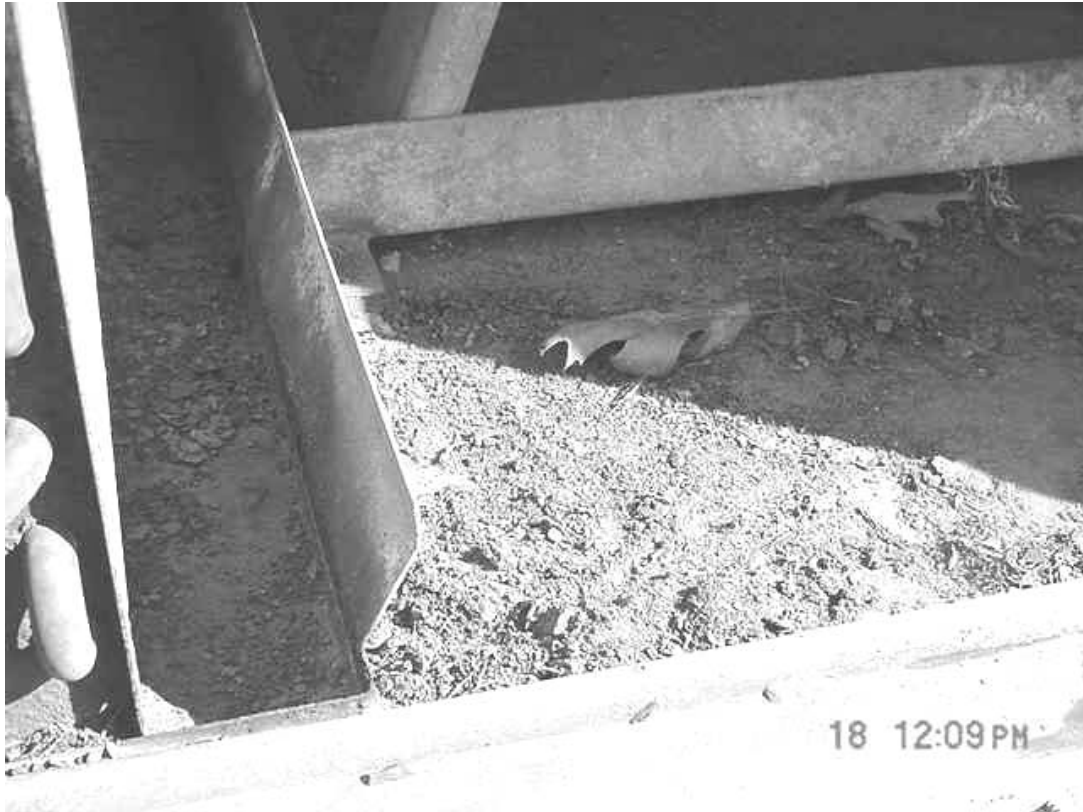
Picture 14

Dirt, Dust and Debris inside Large AHU

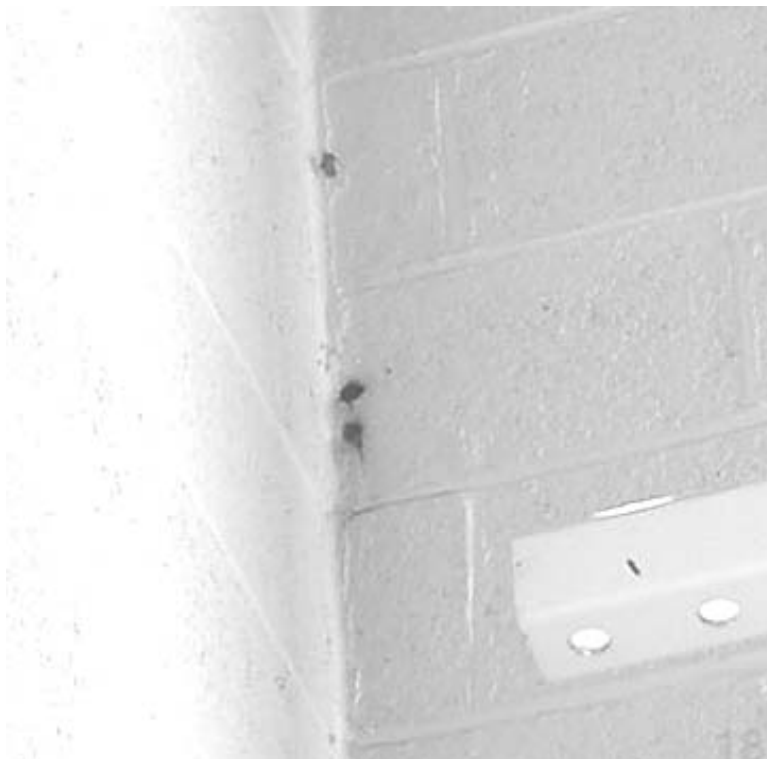
Picture 15

Occupants in the Treasurer's Office expressed mold concerns regarding two black spots located in the corner of an interior wall approximately 15-20 feet high that were reported to be mold (Picture 15). Upon closer scrutiny, the black spots appeared to be holes in the wall in question. Corresponding holes that are located on the exterior wall directly opposite those on the interior were found by MDPH staff, indicating that these holes were likely made for utility pipes/wires (Picture 16). Damage to exterior wall plaster was also observed in several areas (Picture 17). Over time, these conditions can undermine the integrity of the building envelope and provide a means of water entry into the building through capillary action through concrete and/or masonry (Lstiburek & Brennan, 2001). In addition, these breaches may provide a means of egress for pests/rodents into the building.

Black Spots in Corner of Treasure's Office

10. Examine black spots in corner of Treasurer's Office to confirm if they are open utility holes. If so, seal the holes with a proper material.
11. Seal open holes/breaches on exterior of the building to water intrusion drafts and/or pest entry.

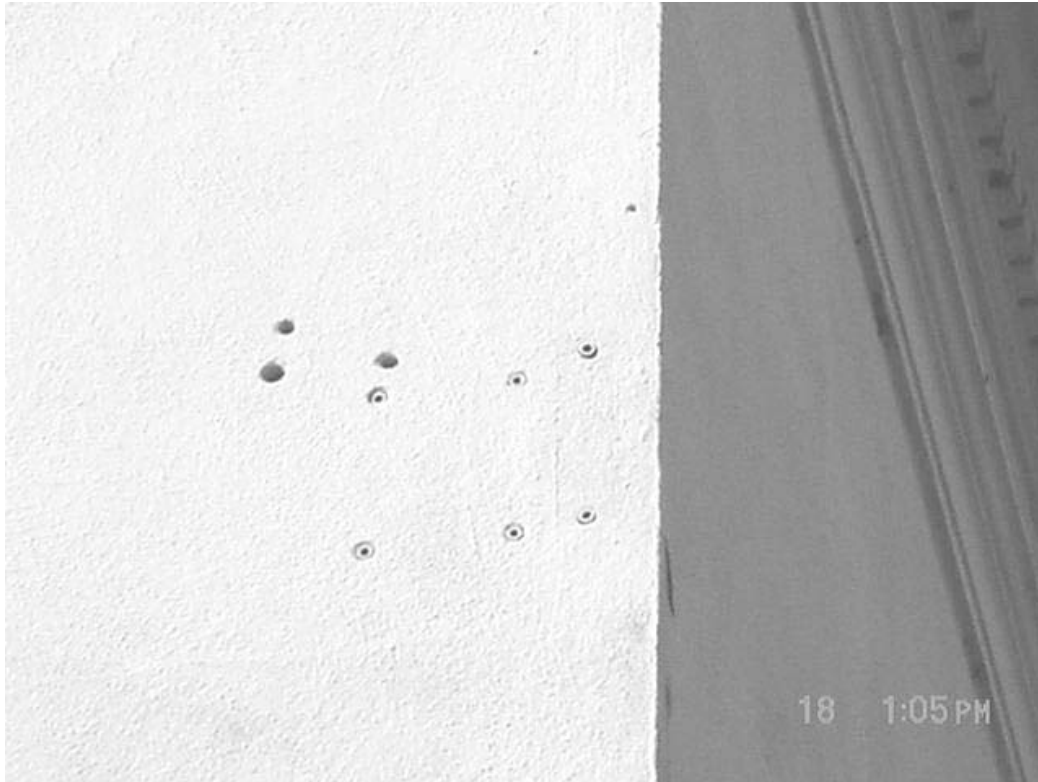
Picture 16

Holes on Exterior of Building Opposite “Black Spots” in Treasure’s Office

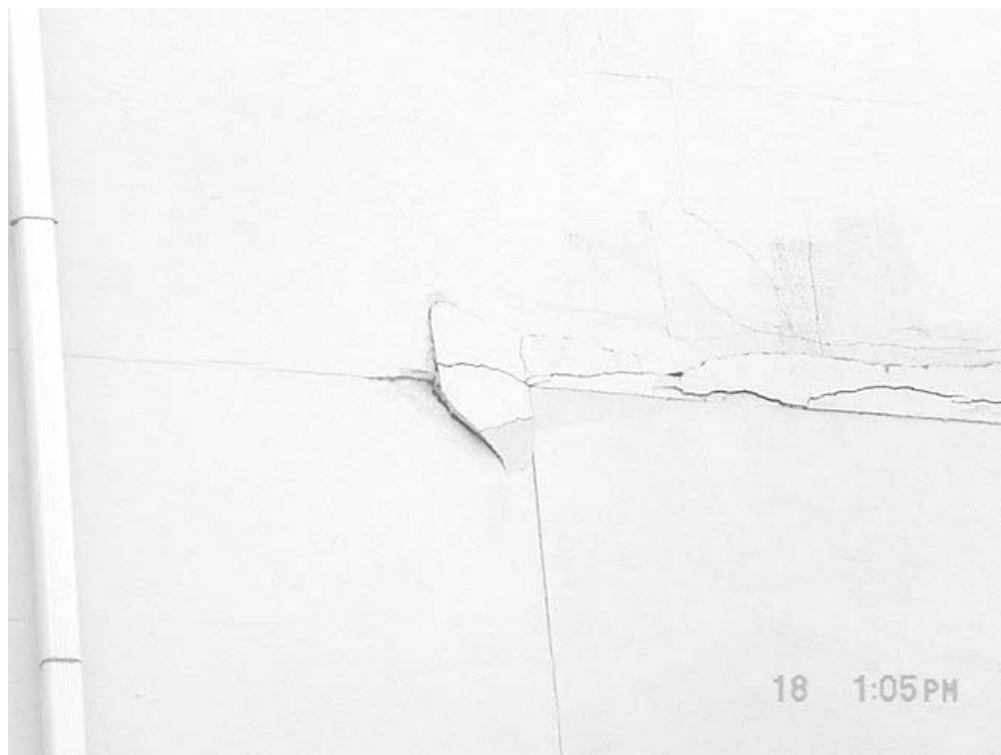
Picture 17

Breach on Exterior Wall Material

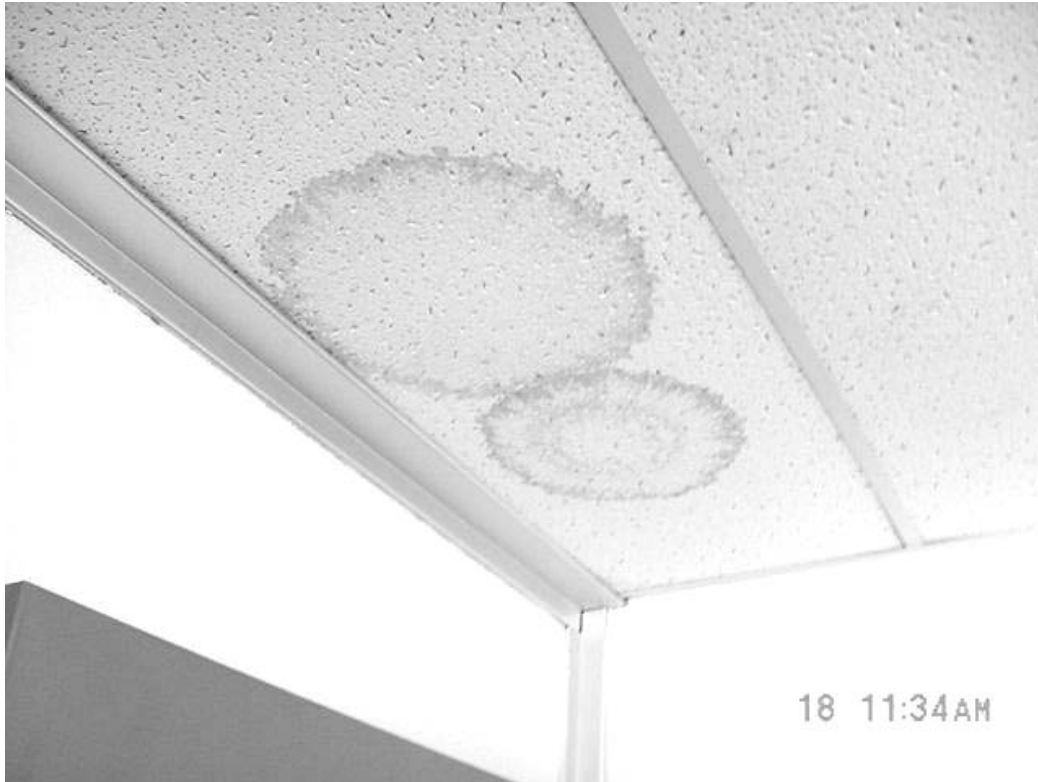
Picture 18

A number of areas had missing and/or water-damaged ceiling tiles in both the NTH and NFD (Pictures 18 and 19), which can indicate leaks from either the roof or plumbing system. Occupants reported that ceiling tiles became damaged as a result of condensation produced during

hot weather by the air conditioning equipment. Water-damaged ceiling tiles can provide a source of mold and should be replaced after a moisture source or leak is discovered and repaired.

Water Damaged Ceiling Tiles in NTH

9. Ensure any roof/plumbing leaks are repaired. Replace any missing and/or water-damaged ceiling tiles and examine the area above and beneath these areas for microbial growth. Disinfect areas of water leaks with an appropriate antimicrobial. Clean areas of antimicrobial application when dry.

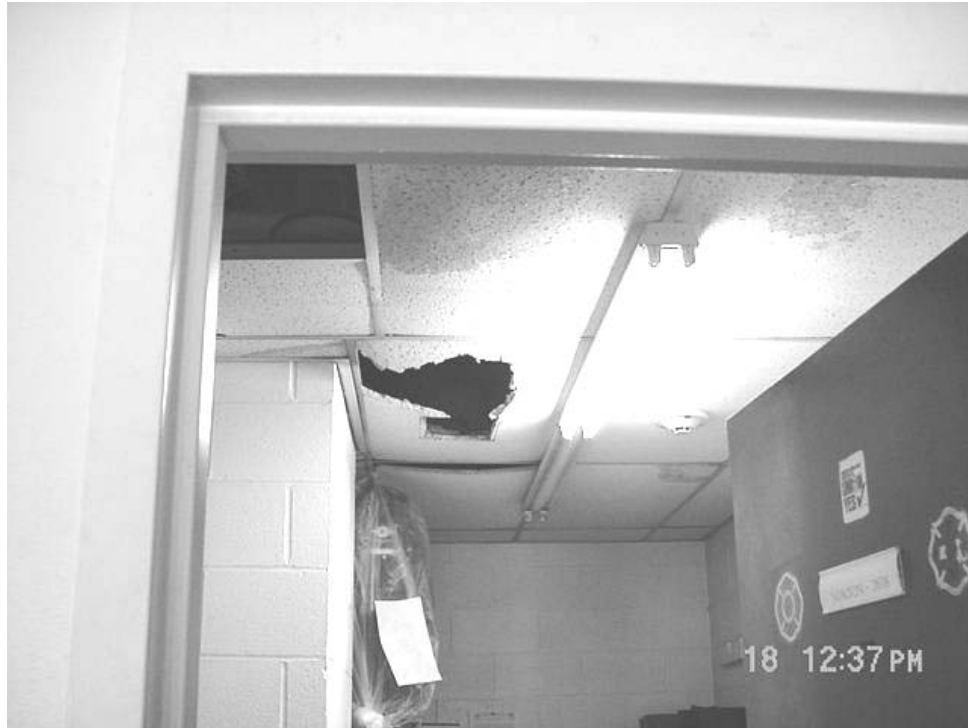
Picture 19

Water Damaged Ceiling Tiles in NFD Union Office

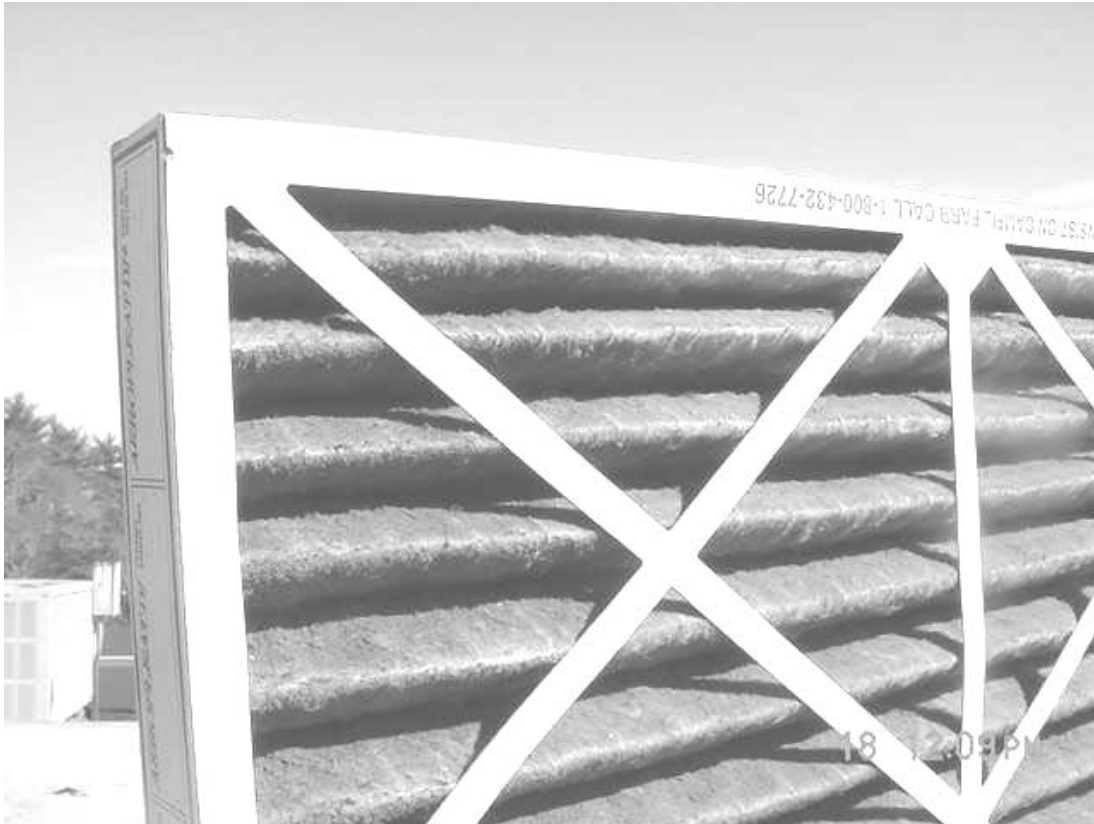
Picture 20

A number of other conditions were noted during the assessment, which can affect indoor air quality. Filters in the rooftop AHUs and return vents in the NFD were examined and found coated with dirt/dust and accumulated material (Pictures 20 and 21). A debris-saturated filter can obstruct airflow and may serve as a reservoir of particulates that can be re-aerosolized and distributed to occupied areas via the ventilation system.

Debris Saturated Filter in Large AHU

15. Clean/change filters for all air handling equipment in the NTH and NFD as per the manufactures' instructions or more frequently if needed.
16. Clean supply/return vents periodically of accumulated dust.

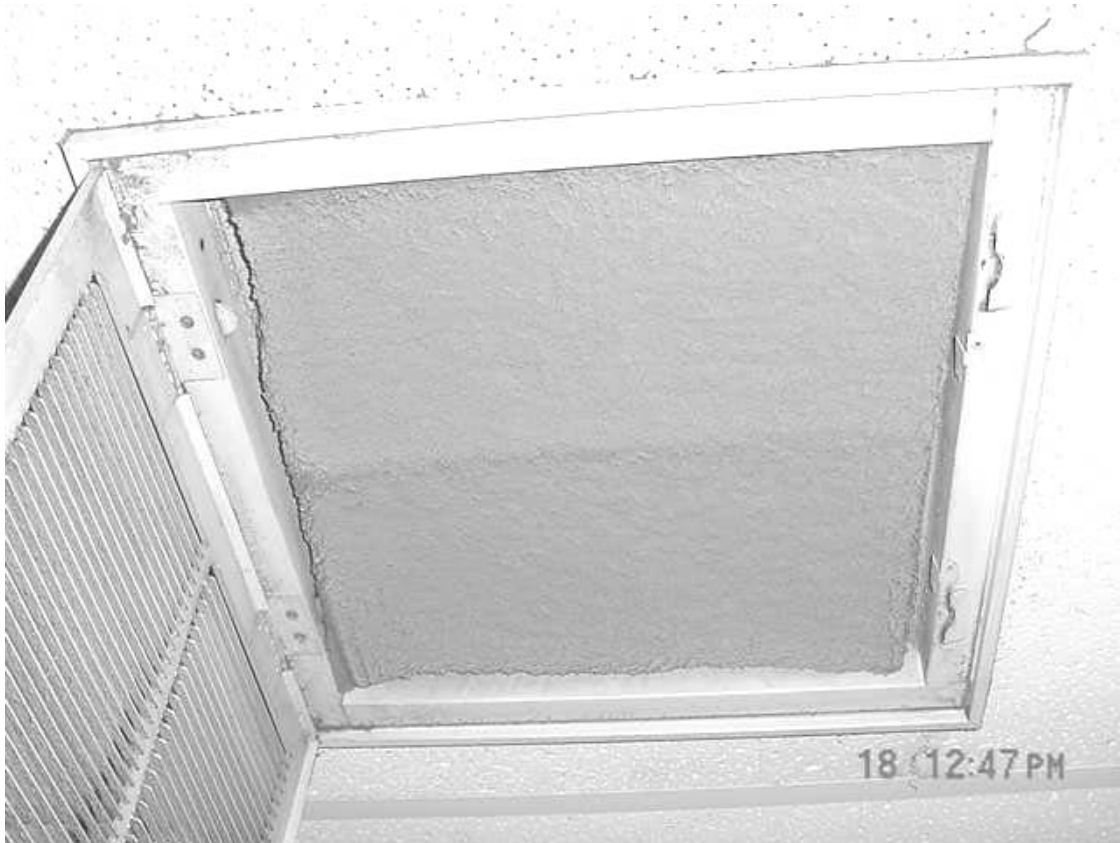
Picture 21

Ceiling-Mounted Return Vent in the NFD Completely Occluded by Dirt, Dust and Debris

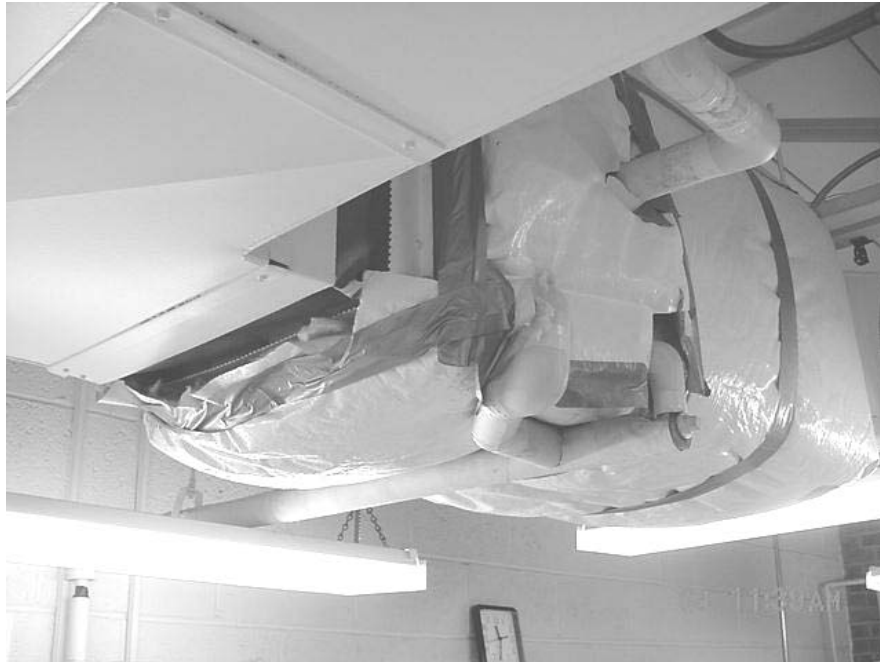
Picture 22

Finally, exposed fiberglass insulation was observed around ductwork in the Recreation Department (Picture 22). Fiberglass insulation can be a source of skin, eye and respiratory irritation to sensitive individuals.

Exposed Fiberglass Insulation around Ductwork in Recreation Department

17. Wrap/cover fiberglass insulation material around ductwork in Recreation Department.
18. Relocate or consider reducing the amount of materials stored in common areas to allow for more thorough cleaning. Clean items regularly with a wet cloth or sponge to prevent excessive dust build-up.
